1' Paved Shoulder

- Harnett County – SR 2215

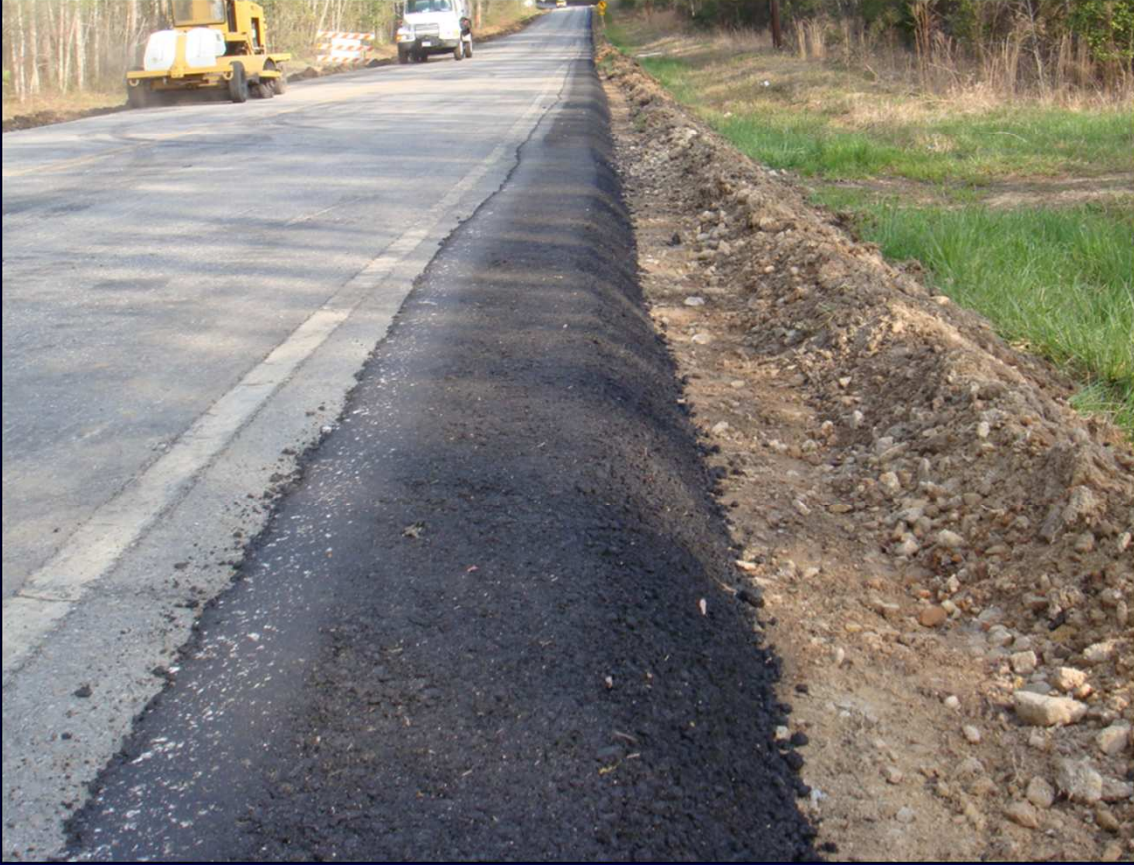
Photos from April 8, 2011. SR 2215 (1.97 miles). 1.5" Lift, Warm Mix. Shoe – NCDOT Prototype 2. Notice the 45 degree edge of pavement left from the 1 foot shoulder extension.

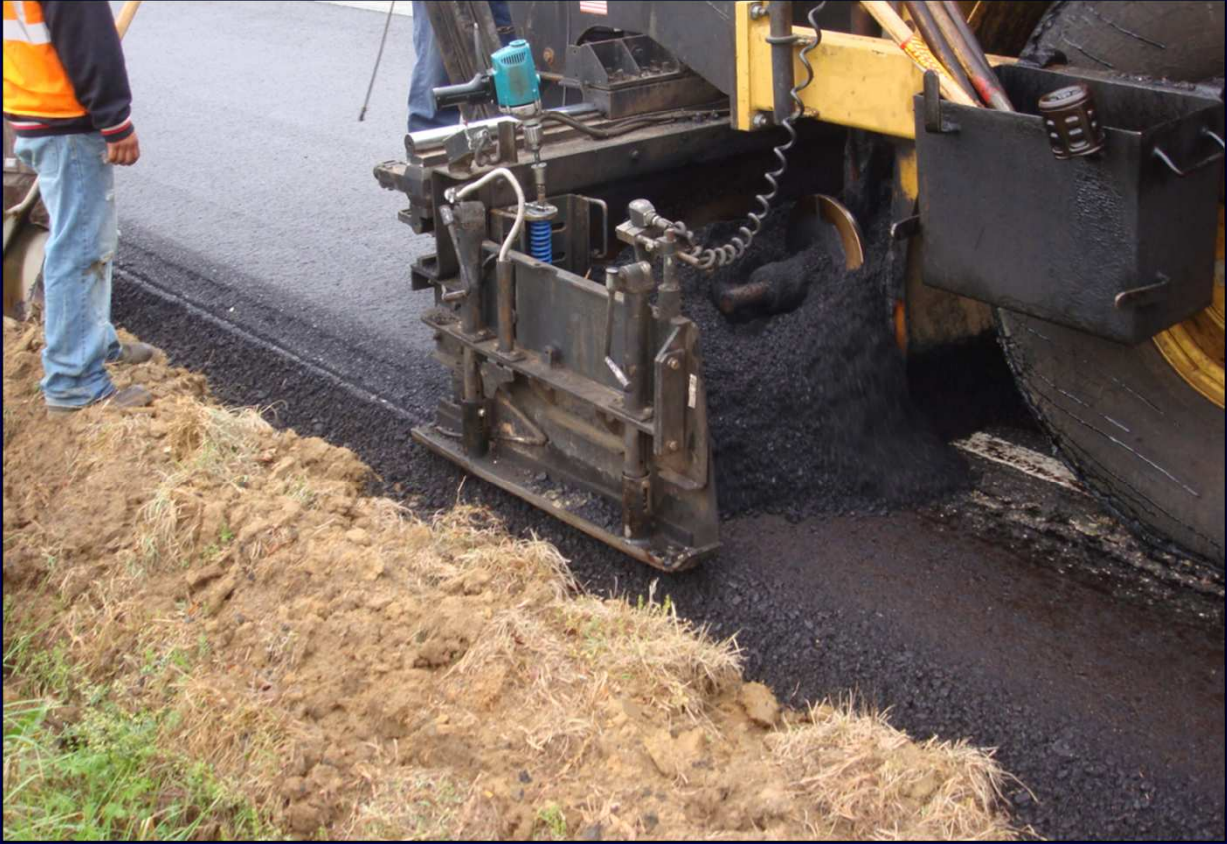
Photos from April 11, 2011. SR 2215 (1.97 miles). 1.5" Lift, Warm Mix. Shoe – NCDOT Prototype 2. The toe of the wedge was placed at the edge of the new sub pavement.

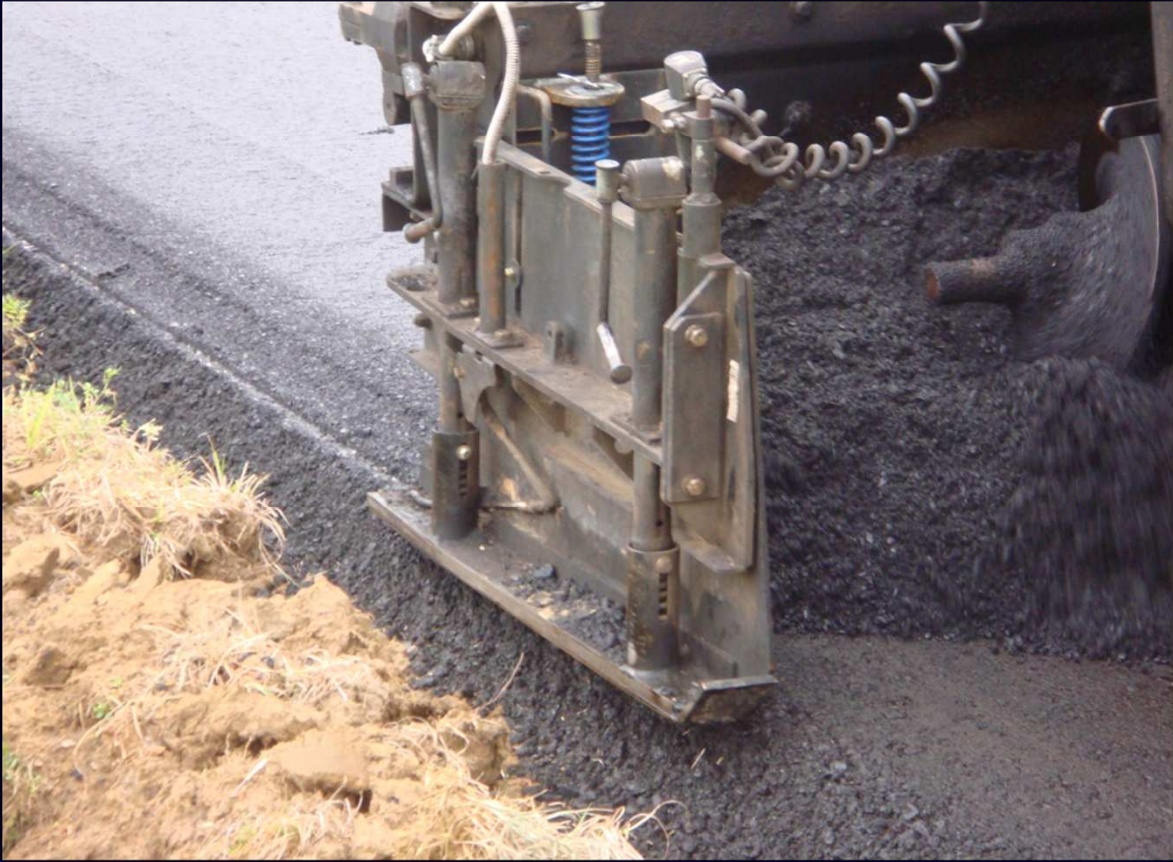
Photos from April 11, 2011. SR 2215 (1.97 miles). 1.5" Lift, Warm Mix. Shoe – NCDOT Prototype 2. The toe of the wedge was placed at the edge of the new sub pavement.

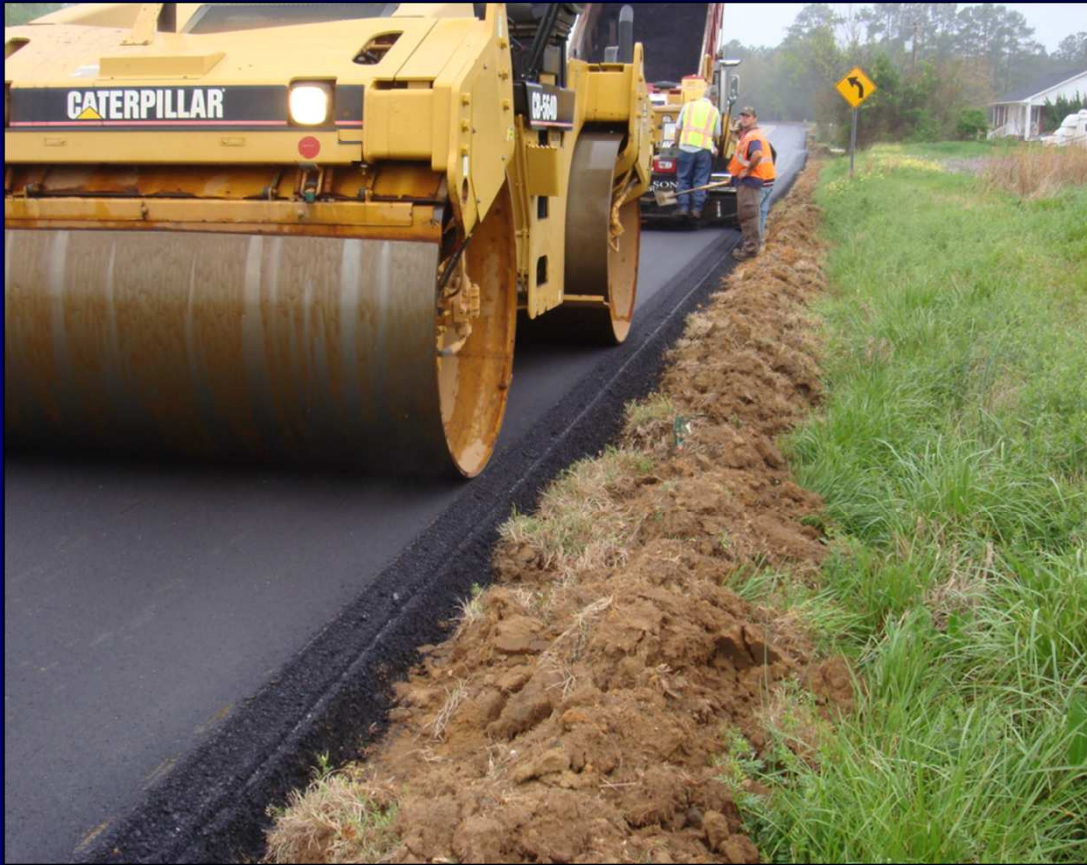
Photos from April 11, 2011. SR 2215 (1.97 miles). 1.5" Lift, Warm Mix. Shoe – NCDOT Prototype 2. The toe of the wedge was placed at the edge of the new sub pavement.

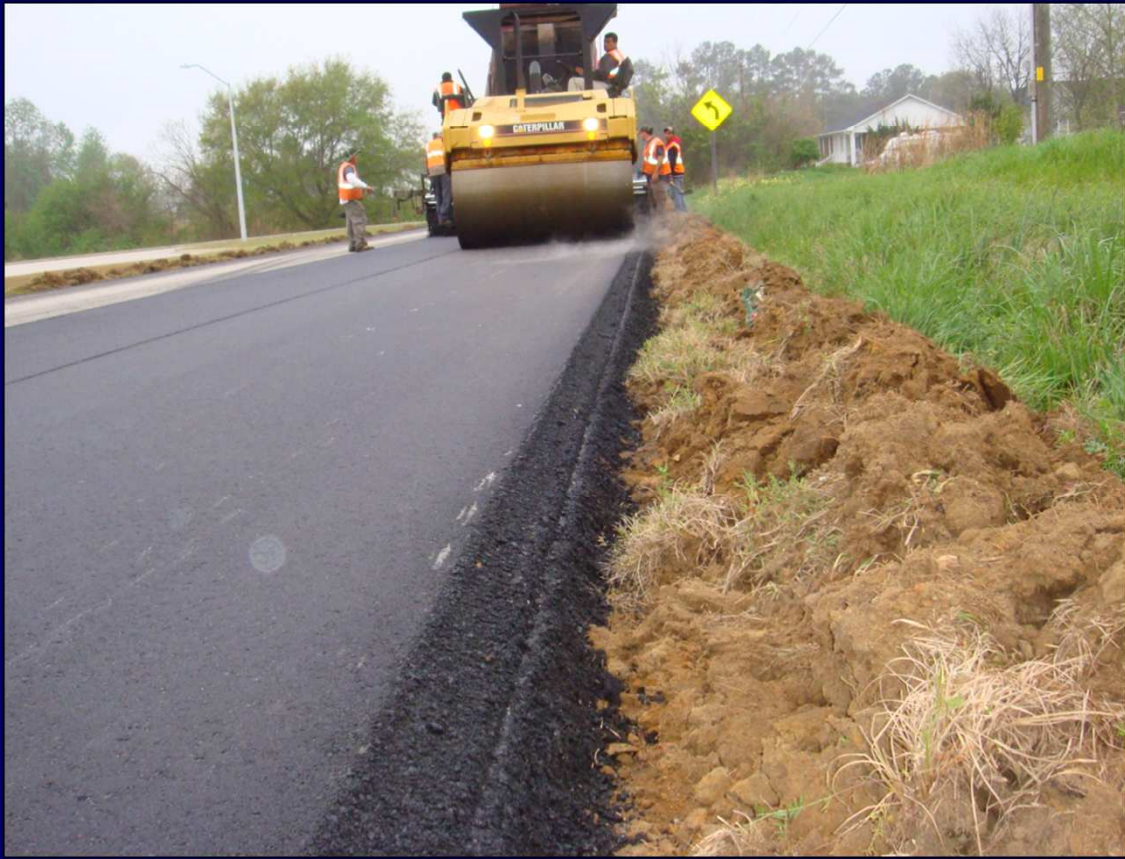
Photos from April 11, 2011. SR 2215 (1.97 miles). 1.5" Lift, Warm Mix. Shoe – NCDOT Prototype 2. The toe of the wedge was placed at the edge of the new sub pavement.
